Subject: Raceway Qualification Test with Pre-Damaged THU2 BTF-0065

**Raceway Qualification Test with Pre-Damaged THU2 BTF-0065**

Key words: Truck Hub Unit, Raceway Qualification Test, Damage

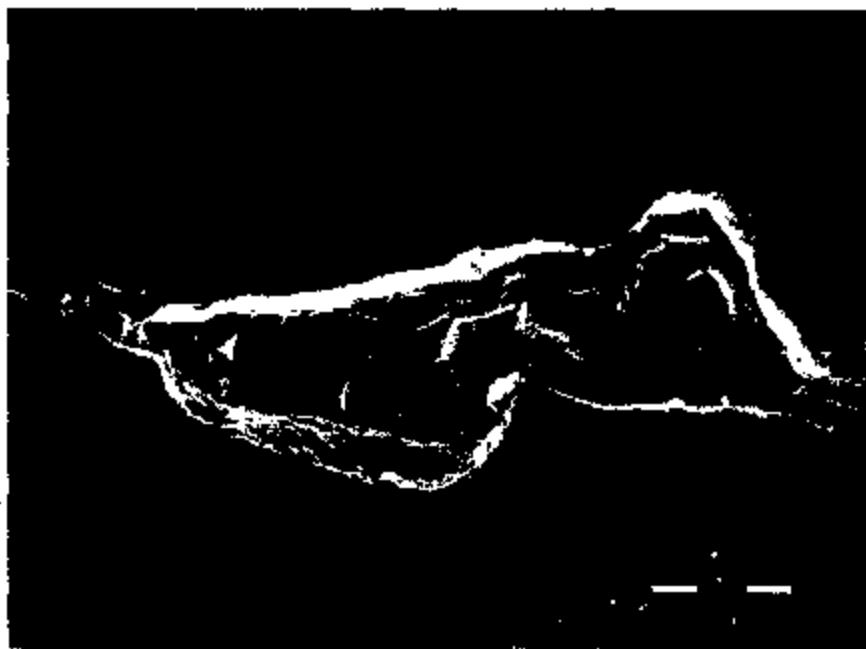
Bild 5: Detail von Bild 4

Picture 5 -- close up of Picture 4 (showing intercrystalline fracture, not sub-surface)

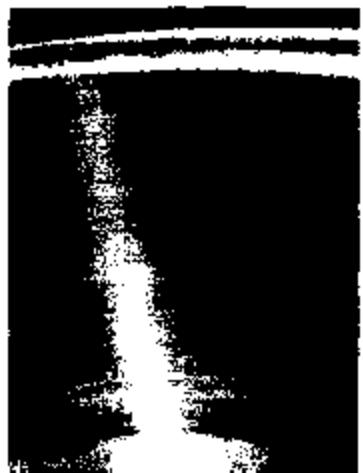
Picture 1: Condition of inboard outer ring raceway before Assembly Test

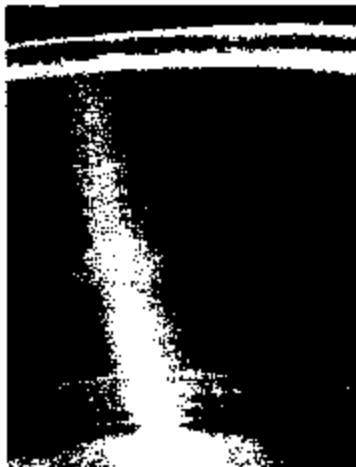
Picture 1: Condition of inboard outer ring raceway before Assembly Test
